CTDEEP General Permit for the Discharge of  
Stormwater from Small Municipal Separate Storm  
Sewer Systems

## IMPERVIOUS AREA DISCONNECTION PLAN

City of Shelton

September 15, 2021

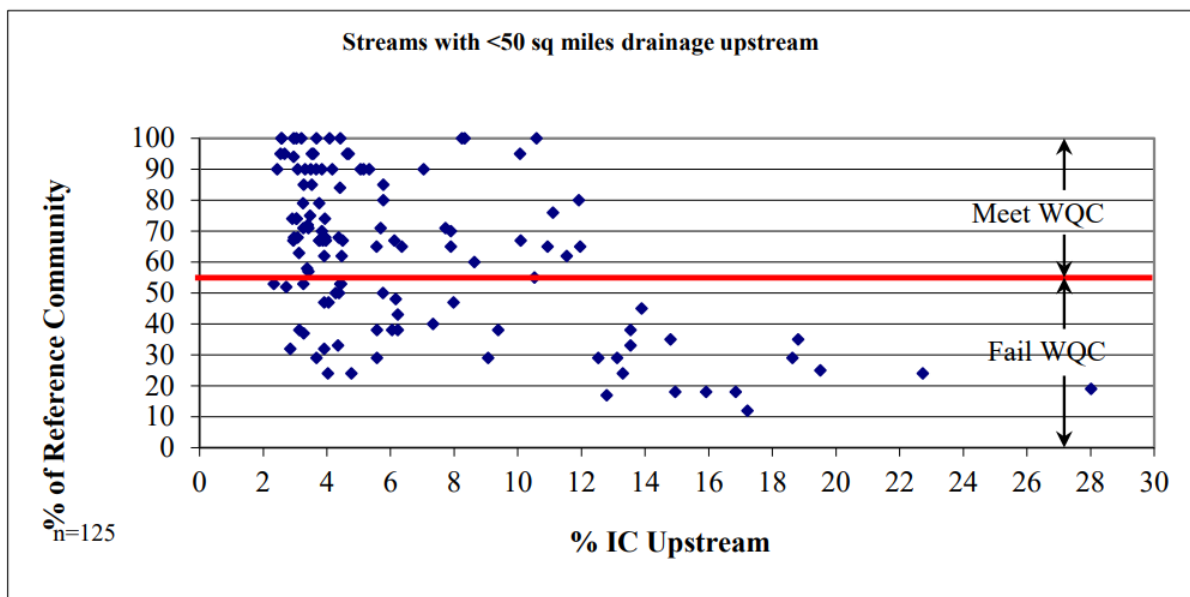
**Figure 2-1.** Scatter plot of impervious coverage relationship to water quality criteria.

**Figure 2-1** below shows a scatter plot from the Connecticut Impervious Cover Watershed Response Plan, that shows all streams with impervious coverage exceeding 12 percent failed to meet water quality criteria.

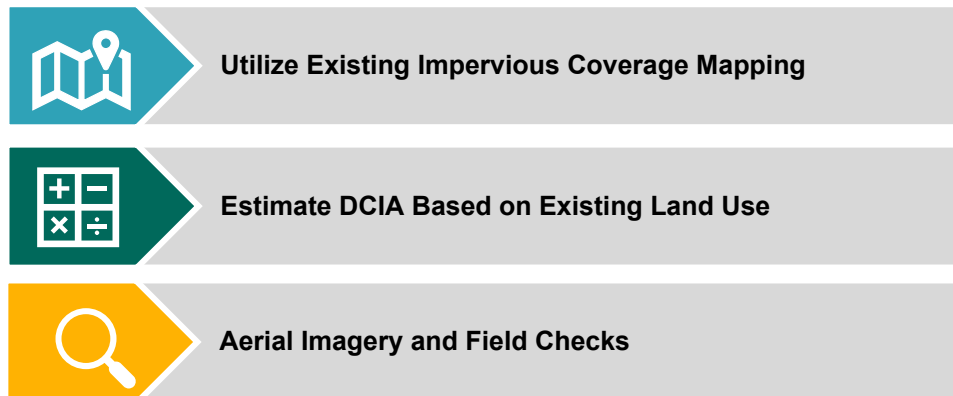
There are three basic approaches to determining the baseline DCIA for the purposes of measuring progress toward the 2% disconnection goal by the end of Permit Year 5.

**Utilize Existing Impervious Coverage Mapping.** CTDEEP in 2012 compiled a GIS data layer that approximates impervious coverage statewide with 1-foot resolution. The impervious coverage (IC) data layer may be used as the baseline data for directly connected impervious coverage (DCIA), but generally overestimates the level of DCIA because the IC data layer assumes all impervious cover is directly connected. Using the existing IC data as the baseline makes meeting the 2% disconnection goal more challenging because the incremental goals are based off the overestimated baseline number.

**Estimate DCIA Based on Existing Land Use.** A more refined estimate of DCIA can be made by evaluating existing land use in a particular watershed. Once baseline IC has been established, DCIA can be estimated using empirical formulas developed by Sutherland as a function of IC for various watershed types (Center for Watershed

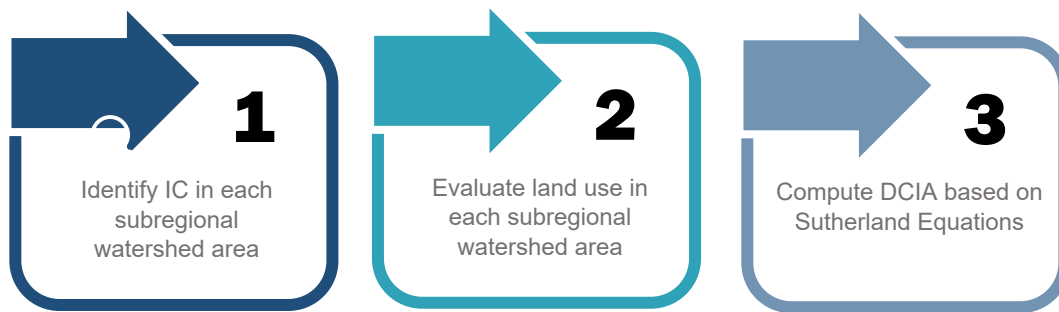
Tighe & Bond performed an analysis of Shelton's DCIA by applying the Sutherland Equations. We began our analysis using the 2012 IC data layer, and then evaluated the land use in each subregional watershed area within the City, applying the appropriate equation from Table 2-1.

We applied the Sutherland equations to the 2012 CTDEEP IC value in each subregional watershed within the City. Where a subregional watershed extended into another municipality, we clipped the impervious coverage to the City's border so that only the portion within the City would be reflected in the computation. The analysis for each subregional watershed appears in **Appendix A**.

**1,591.96**  
acres  
DCIA

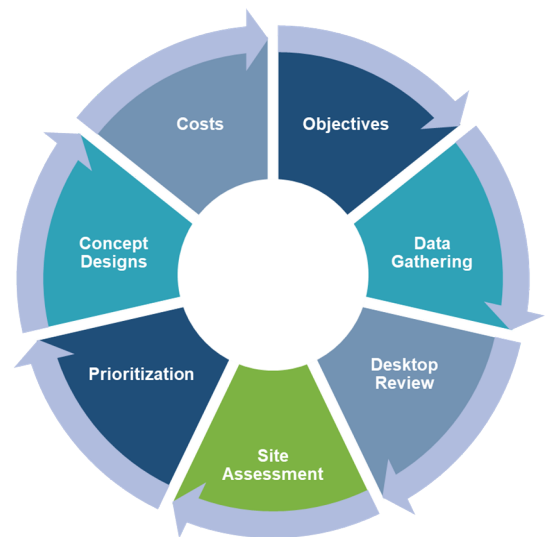
The general process is outlined below:

- Identify objectives
- Gather data
- Review available data
- Reinforce with site visit
- Prioritize sites
- Develop concept designs
- Identify construction and maintenance costs

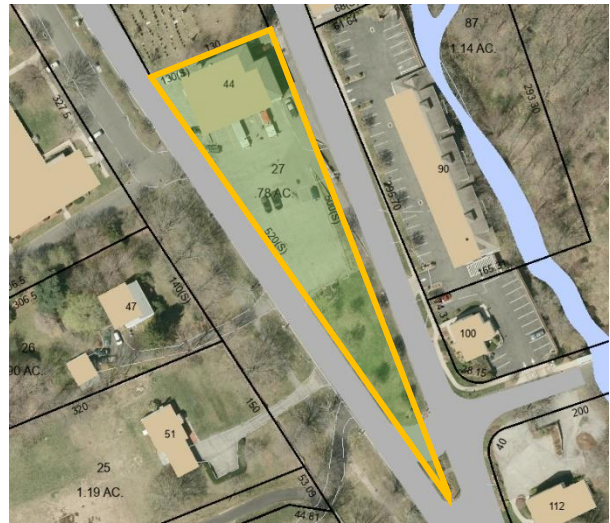
#### Huntington Fire Department 44 Church Street

The site is mostly impervious, consisting of the fire department building and surrounding parking areas. There is a triangular pervious lawn area on the southern portion of the site where a small brick memorial walk and plaza is located. The site is underlain by HSG Group B soils which makes it suitable for infiltration practices. Infiltration practices should be set back from the eastern portion of the site to avoid introducing hydrostatic pressure against the adjacent retaining wall.

Recommended BMPs: Rain Garden

Another potential BMP that could be considered in this area would be porous pavement, for the parking area, though the placement of porous pavement near the retaining wall would need to be evaluated. Additionally, the load supporting capabilities of porous pavement would also need to be evaluated because of the weight of the fire apparatus.

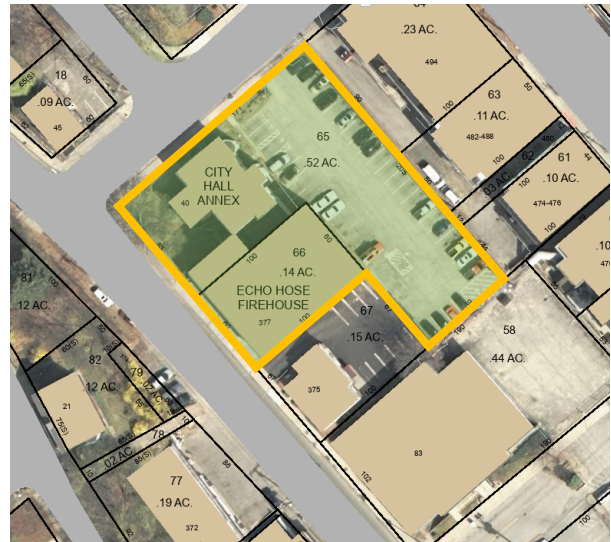
**City Hall Annex**  
**40 White Street**

The underlying soils are classified as Urban Land, which is classified as HSG Group D, which would ordinarily limit infiltrative capacity of the soil. Soil exploration will be necessary to determine depth to restrictive layer and to determine infiltrative capacity of the soil. We have assumed that loss of parking spaces would be undesirable. Similarly, due to the steepness and proximity of the lawn area to the City Hall Annex, rain gardens would not be an effective solution at this location. Porous pavement may be a possibility for the parking area.

We noted that there are roof downspouts along the rear of the buildings which could be directed into drywells that could be constructed in the parking lot. Assuming that the rear of both buildings can be directed into drywells, we estimate four 8 foot deep, 8-foot diameter drywells would be required to treat the water quality volume from the rear roofs of these structures.

## Recommended BMPs: Drywells

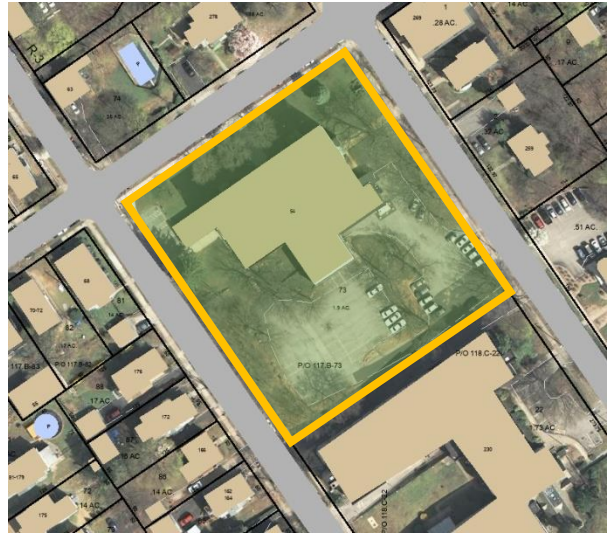
#### City Hall 54 Hill Street

The site sits on a topographic high point relative to the streets to the north and east. The parking lots on the south and east sides of the building are terraced with the prevailing grade, which runs from west down to the east. Since the slopes between tiered parking areas are relatively steep, curbing is required to prevent runoff from sheeting off the pavement and eroding downstream slopes, therefore vegetated swales or infiltration trenches along the edge of the parking area will be ineffective.

The NRCS Soil Survey indicates that the underlying soils are HSG B, which are suitable for infiltration practices, but the steepness of the site limits the ability to site large-scale practices. Instead, small scale practices could be applied individually around the building.

Recommended BMPs: Rain Garden

An alternative approach would be to construct drywells within the parking areas to treat the water quality volume, and have piped overflow into the drainage system on adjacent City streets.

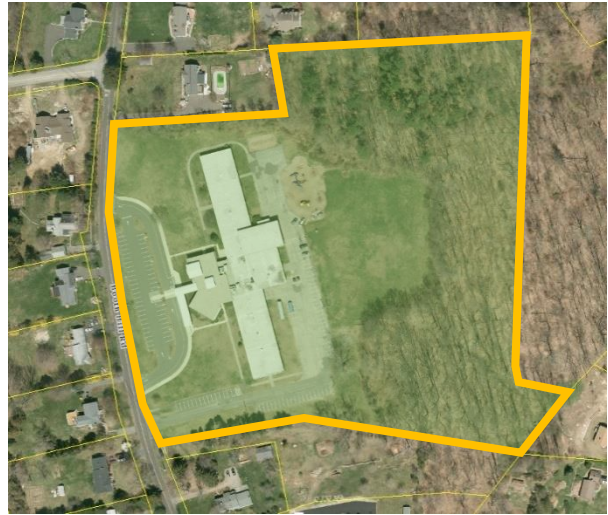
#### Booth Hill Elementary School 544 Booth Hill Road

Runoff from the western side of the site is directed into storm drains in Booth Hill Road, so runoff in this direction is not considered disconnected under existing conditions. There are multiple options for disconnection for the parking lot in front of the school. The NRCS Soil Survey indicates that most of the underlying soils are HSG Group B soils, which lend themselves well to infiltration.

The existing parking lot is curbed, and the curbing on the western edge of the parking lot could be removed in favor of an infiltration trench running the length of the edge of the parking.

Alternatively, rain gardens could also be used to infiltrate runoff from the building, provided that the location of the rain gardens does not interfere with outside school programming.

Recommended BMPs: Infiltration Trench  
Area disconnected: 0.36 acres

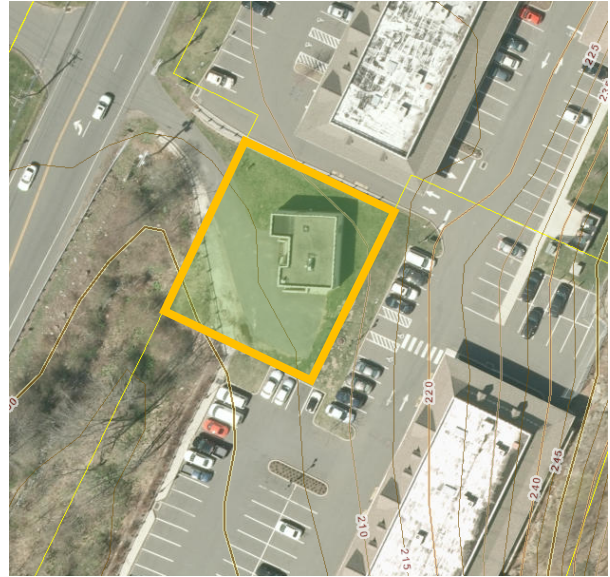
##### Bridgeport Avenue Pump Station 514 Bridgeport Avenue

The driveway could be disconnected if an infiltration trench were placed along the edge of the parking area closest to the watercourse, provided that the trench were sized to accommodate the infiltration of the water quality volume.

The NRCS Web Soil Survey shows that the underlying soils are HSG B and D, which indicates that infiltration potential may be limited.

Should soil exploration indicate that underlying soils are not conducive to infiltration, an alternative may be to replace the crushed stone with stabilized grass pavement to extend the buffer wide enough so that the width of the buffer exceeds the width of the contributing area.

Recommended BMPs: Infiltration Trench  
Area disconnected: 0.07 acres

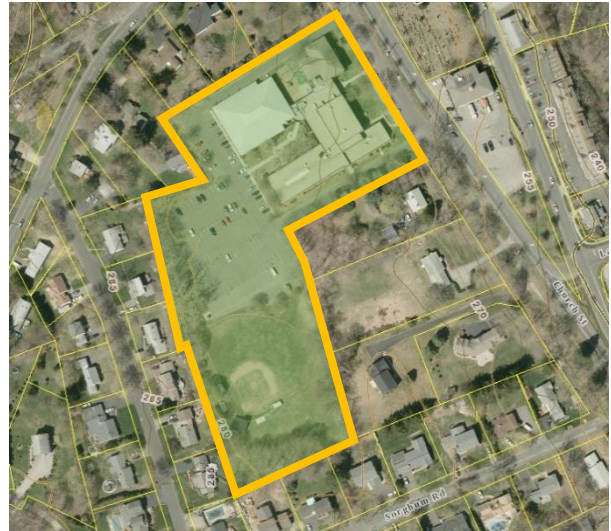
##### Shelton Community Center 44 Church Street

The site slopes from west to east. The underlying soils are HSG B, which makes them favorable for infiltration practices. However, since the parking lot generally slopes toward the building, opportunities for retrofits are more difficult, since infiltration trenches and similar practices are best placed along edges of parking away from the building due to pedestrian traffic.

An additional BMP that may contribute significantly to disconnection at this location is converting the northern portion of the parking area to porous pavement.

Recommended BMPs: Rain Garden  
Area disconnected: 0.30 acres

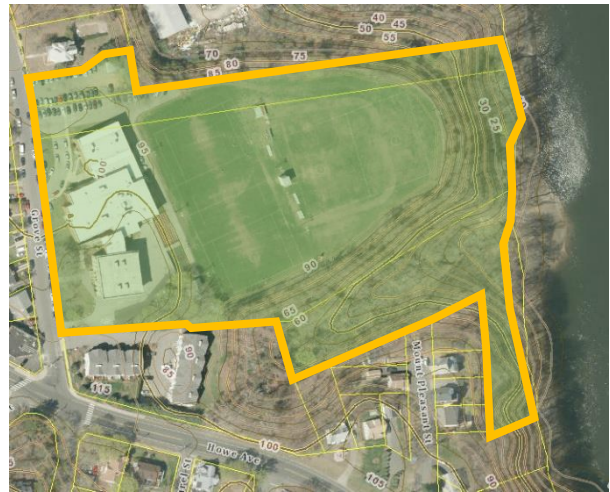
#### Former Lafayette Elementary School 44 Church Street

The building, which sits on the high point of the site, has several fields located behind it. The landscaped area in front of the school along Grove Street varies topographically, with steep sections and flatter areas. The area immediately surrounding the school has HSG Group B soils, while the parking areas to the two parcels to the north sit atop HSG Group D soils, making them less conducive for infiltration practices.

The northernmost parcel drains directly to Grove Street, but since it lies on poor draining soils, disconnection may not be possible. The parking area immediately north of the building on the narrow parcel, and the front portions of the building roof itself are better candidates for disconnection using several small rain gardens scattered around the Grove Street side of the building. Several downspouts on the building discharge directly to grade under existing conditions.

We considered the potential for a water quality swale in the island of the northern parking lot, but the swale in the island could potential pose a barrier to pedestrian travel from the parking area toward the building.

Recommended BMPs: Rain Garden  
Area disconnected: 0.29 acres

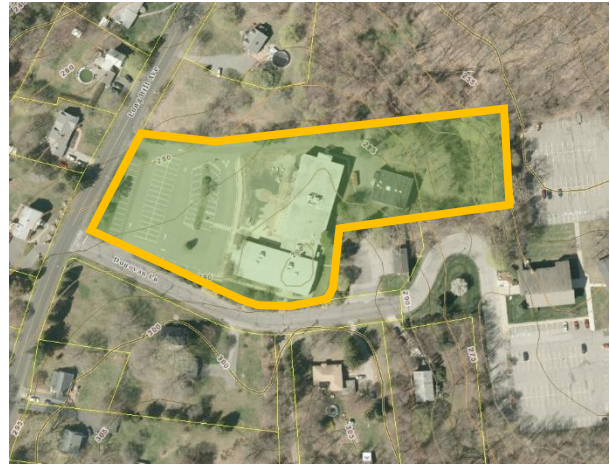
##### Shelton Board of Education 382 Long Hill Avenue

The western part of the site, where the impervious cover is located, slopes from east to west toward Long Hill Road, with a steep slope and partial berm at the lowest edge of the parking area, which would make any perimeter stormwater BMPs, such as infiltration trenches or swales difficult to install due to their disruption of the berm or being located at the top of the slope.

Due to the relative steepness of the parking area, the parking area is likely a poor candidate for conversion to porous pavement.

Recommended BMPs: Rain Garden  
Area disconnected: 0.12 acres

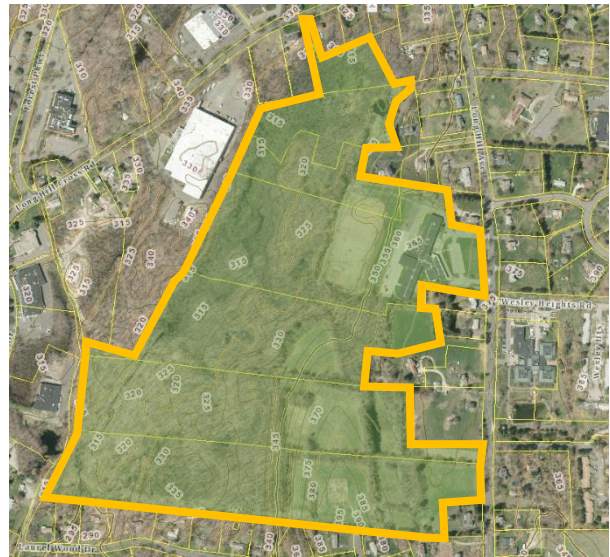
#### Long Hill Elementary School 565 Long Hill Avenue

The area between Long Hill Avenue and the school slopes toward the school, while the area behind the school slopes westward toward the athletic fields. The underlying soils immediately under the school are HSG B, while those to the east and west of the building are a dual group HSG C/D, where long-term infiltration would be challenging, but infiltration for only water quality volume could likely be accommodated.

We considered a swale on the western edge of the service drive, but the slope down to the athletic field is approximately 15 percent, which would require significant regrading to accommodate the swale, which would only steepen the slope.

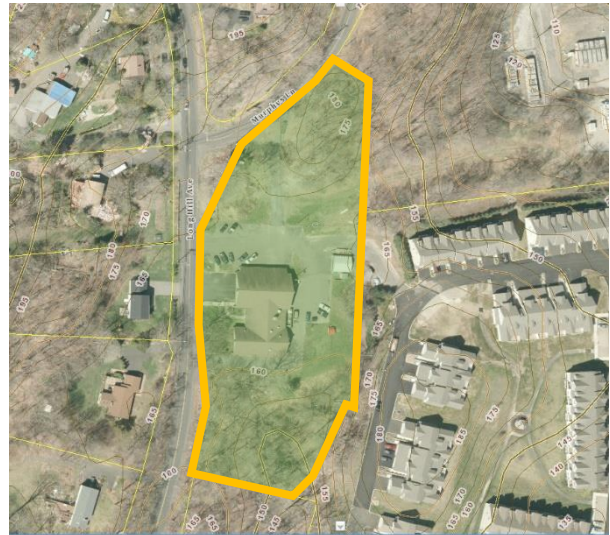
##### Pine Rock Park Fire Station 722 Long Hill Avenue

An infiltration trench along the northern edge of the north parking area between the Murphy's Lane secondary driveway and Long Hill Avenue, would disconnect approximately 6,800 square feet of pavement and the northwest corner of the building road since downspouts discharge directly to grade. However since underlying soils are HSG D, the underlying soils will need to be evaluated in greater detail.

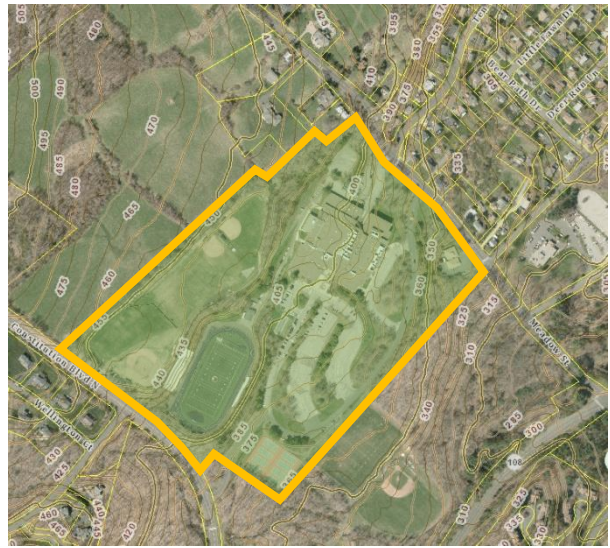
#### Shelton High School 120 Meadow Street

A supplemental measure that could also be explored is a rain garden in the lawn area at the southeast corner of the Ambulance Corps parking to treat runoff from the parking lot, which is mostly without curbing. Additional study will be required since this area of the property is a Class A aquifer protection area.

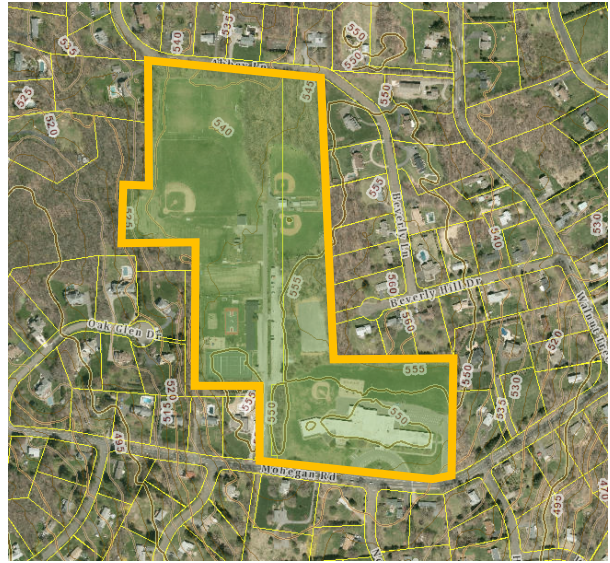
**Mohegan Elementary School**  
47 Mohegan Road

There are also some opportunities at the elementary school. For example, the curb could be removed from the south edge of the pick-up/drop-off loop, and an infiltration trench could be placed along its length, disconnecting up to 11,500 square feet of directly connected impervious surface.

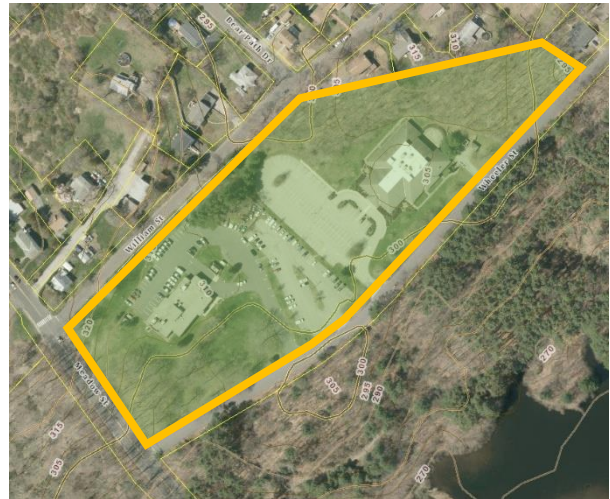
**Shelton Police Department**  
85 Wheeler Street

We evaluated a potential rain garden feature along the frontage of the police department, but there are a significant number of mature trees that would be impacted, so we ruled that out. The grassed areas along the front of the Senior Center offer the best opportunity. There is an existing swale that runs along the front of the Senior Center along Wheeler Street that could be converted to a water quality swale, with the front roof leaders piped to the swale, disconnecting 0.22 acres of roof area. We do not recommend removing the curbing because of the proximity and steepness of the adjacent slope.

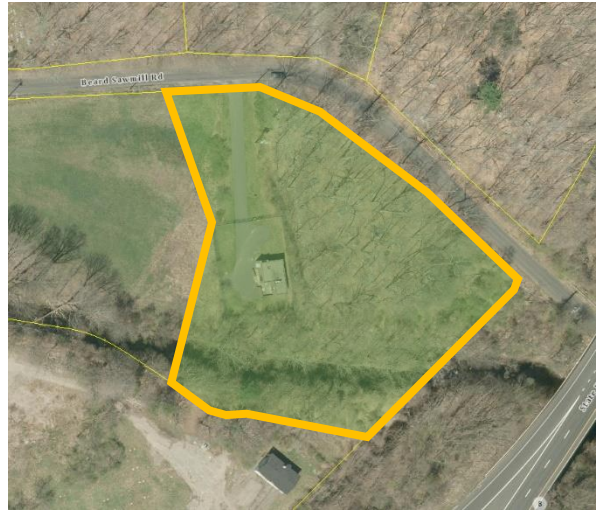
The pump station is served by a driveway, which is not curbed, allowing runoff to discharge off the driveway. The building has downspouts that discharge to grade.

The site is fairly flat, and the distance to the Far Mill River is significant enough to allow for water quality treatment along the vegetated buffer.

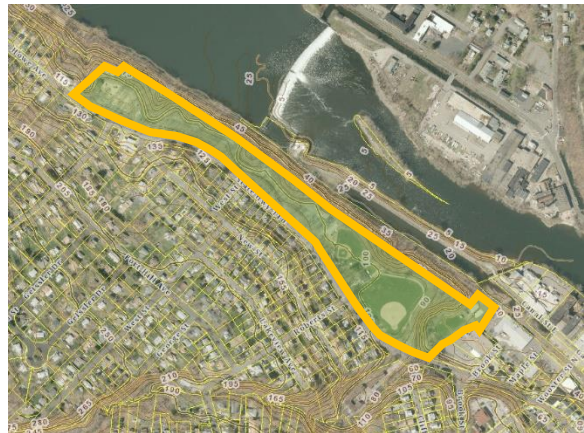
Shelton Riverview Park is a 17.7 acre parcel between Howe Avenue and the Housatonic River. The parcel contains a few small buildings, but they are generally surrounded by larger grassed areas which essentially disconnects them. There is a mixture of paved and gravel parking areas, a baseball and softball fields, and a basketball court. All impervious surfaces drain northeastward toward the river and across a wide, wooded buffer, disconnecting the site.

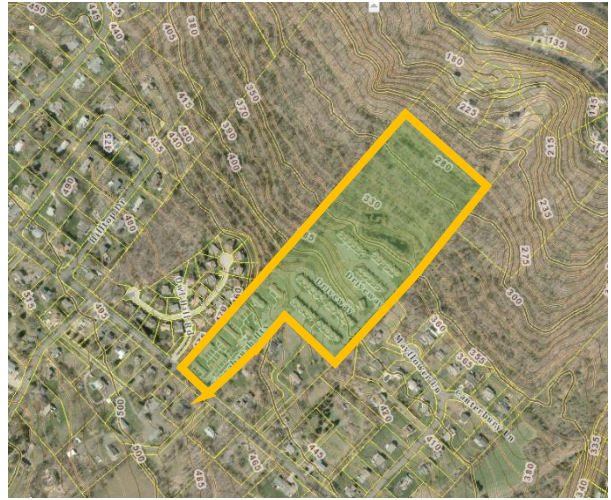
The developed portion of the site drains to a detention basin located at the bottom of the slope, below the lowest units, disconnecting the impervious coverage on the site with intermediate treatment.

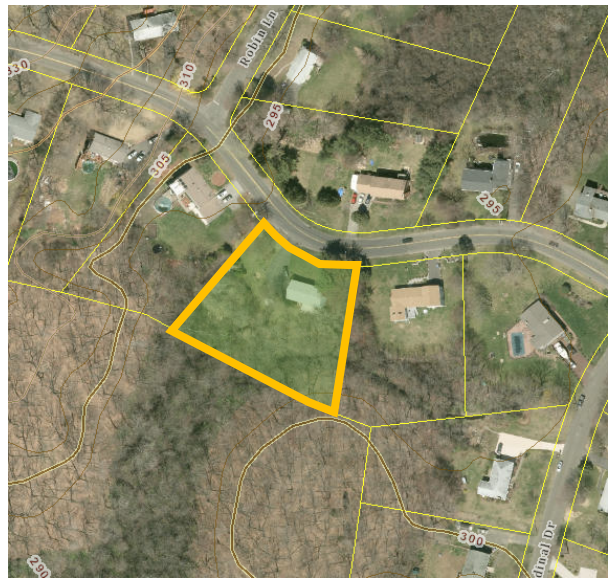
The Meadowlark Drive Pump Station is located between 12 and 16 Meadowlark Drive on an easement between two residential parcels. The area around the pump station sheets off to adjacent woodland and is therefore considered to be disconnected.

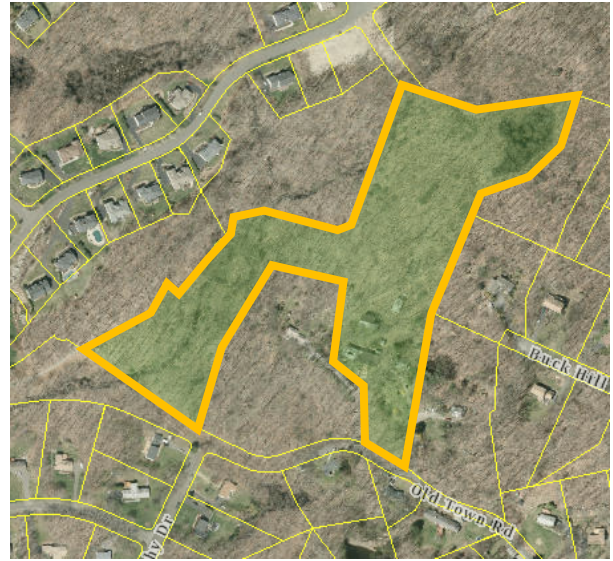
The City of Shelton came into possession of this 13.14 acre parcel that has three residential buildings. The property is substantially wooded, and is served by a driveway that has no curbing. Runoff sheets off the driveway into the woodlands, and therefore, the property is already disconnected.

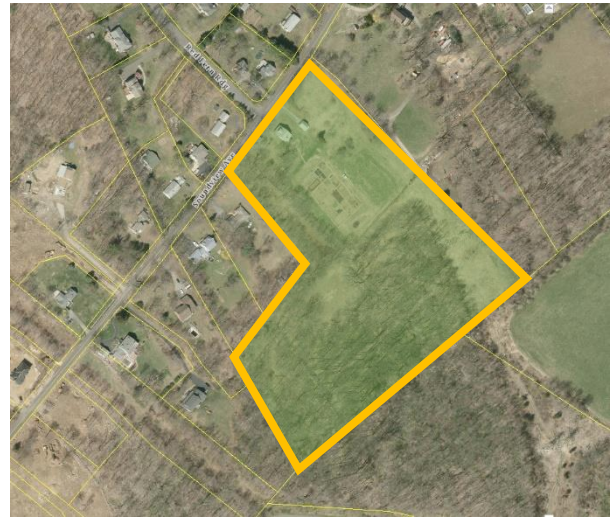
The City of Shelton came into possession of this 13.91 acre parcel that has a residential buildings. The property is partially agricultural land, and partially wooded, and is served by a driveway that has no curbing. Runoff sheets off the driveway onto adjacent pervious areas of sufficient width, and therefore, the property is already disconnected.

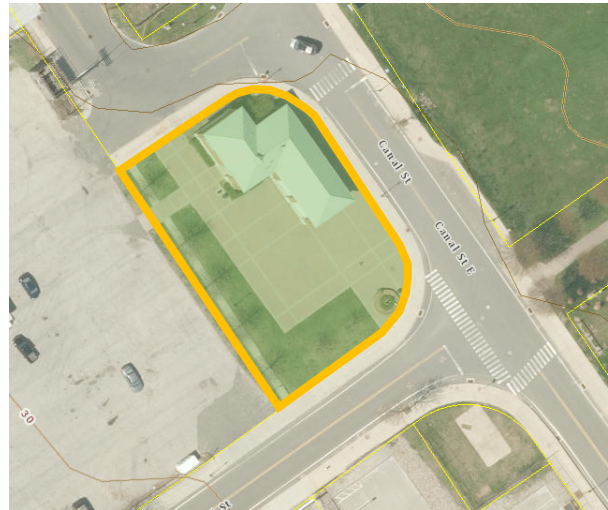
**Farmer's Market Building  
100 Canal Street**

The underlying soils are Hydrologic Soil Group D, which limits infiltration practices. A water quality swale could be used to intercept stormwater runoff in the green space west and south of the plaza, but it would disturb existing trees. It is unclear if excavation for stormwater management features would also impact any potential underlying environmental restrictions due to the site having previously been a brownfield. Therefore, we do not believe this site is suitable for stormwater retrofits.

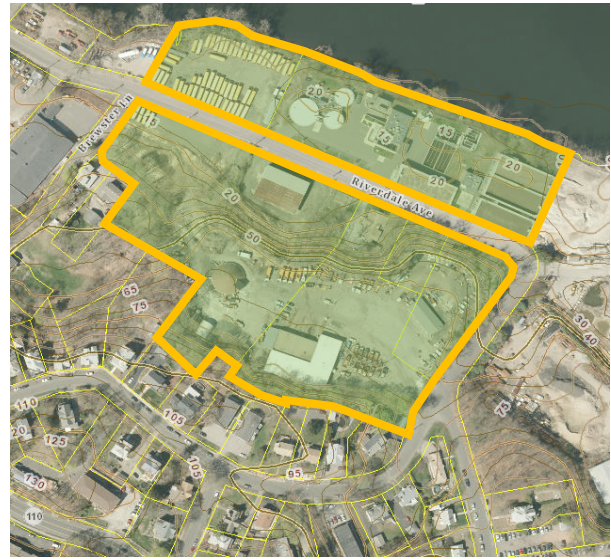
**DPW – WPCF – Bus Depot – Animal Shelter**  
41 Myrtle Street  
25 & 55 Riverdale Avenue  
11 Brewster Place

Our review indicated that these properties would be unsuitable for disconnection practices due to the extent of development that is necessary for their function, the fact that some of these operations involve the storage and handling of fuels and chemicals that are considered stormwater risks, and the overall slope of the property. The lower edges of these properties all sit at the top of very steep slopes, and introduction of large-scale infiltration practices could saturate the slopes and cause stability issues.

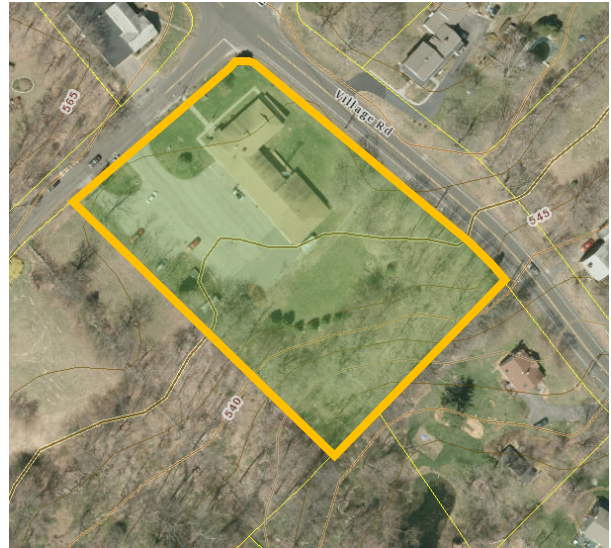
#### East Village Fire Department 2 School Street

The predominant grade across the site is from northwest to southeast, though the parking lot drains to a catch basin in the center of the parking. Although underlying soils are HSG B, and generally favorable to infiltration practices, disconnection would require the regrading of the parking lot to slope entirely to the southeast toward the lawn and wooded area, which would negatively impact the apparatus bays.

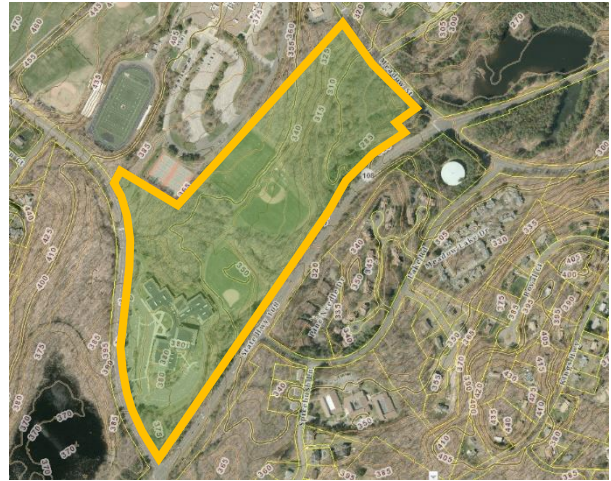
#### Shelton Intermediate School 675 Constitution Boulevard South

The school building and grounds opened in September 2001. Therefore, it is likely that there are existing stormwater BMPs in effect that provide disconnection, but we cannot verify that these BMPs exist.

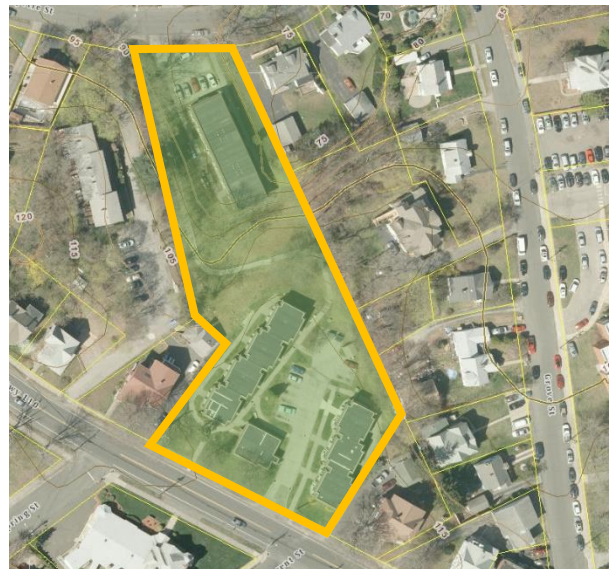
#### Helen DeVaux Apartments 91 Howe Avenue

The underlying soils are HSG D, and therefore do not lend themselves well to infiltration. Although the site is located in a significantly developed portion of the City, it does not have any significant streetscape area that would enable the use of stormwater management practices used in highly developed areas, such as stormwater tree pits. The site is separated by a significant slope, with the lower

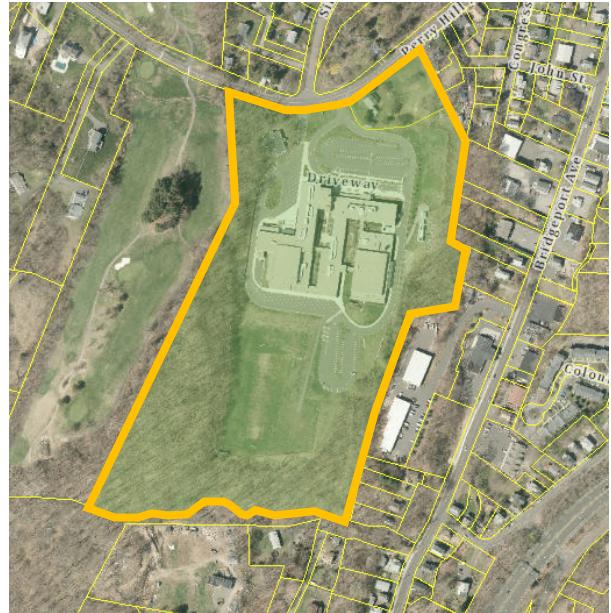
**Perry Hill School**  
**60 Perry Hill Avenue**

However, there may be opportunities, but on-site soils investigation will be required. For example, the rear parking area has a center island which could be converted to a depressed parking island, but the underlying soil profile is unknown.
